Life cycle assessment of refurbishment scenarios to confined tank structures at a waste water treatment plant

ABSTRACT: The paper will show a Life Cycle Assessment (LCA) of three different refurbishment scenarios for confined tank structures at a waste water treatment plant. – One using a traditional Portland cement based repair mortar, one combining this cement repair mortar with a reactive protective coating, and one using 100% calcium aluminate based repair mortar technology. In order to evaluate the sustainability and potential environmental impact of each of the three scenarios, the Life Cycle Assessments (LCA) were performed, which included Cumulative Energy Demand (CED), Global Warming Potential (GWP) and Photochemical Ozone Creation Potential (POCP). The results are compared and analyzed in this paper, particularly in relation to extending the structural service life, which shows how innovative systems can give advantages to designers and contractors, which in turn are also of benefit to their customers.

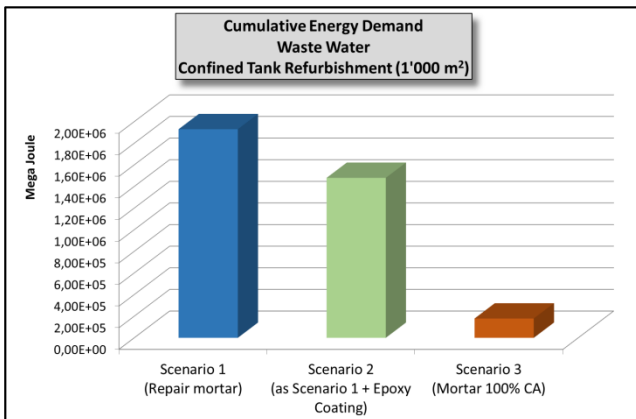
Fig. 1: Cumulative Energy Demand for a lifespan of 50 years.

Scenario-3 has the lowest impact to primary energy from renewable and non-renewable resources.

When compared to the Scenario-1, the energy saving per year using the 100% calcium aluminate mortar is equivalent to the energy required to produce ~40 tons of oil (and to ~28 tons of oil when compared to the system used in Scenario-2).

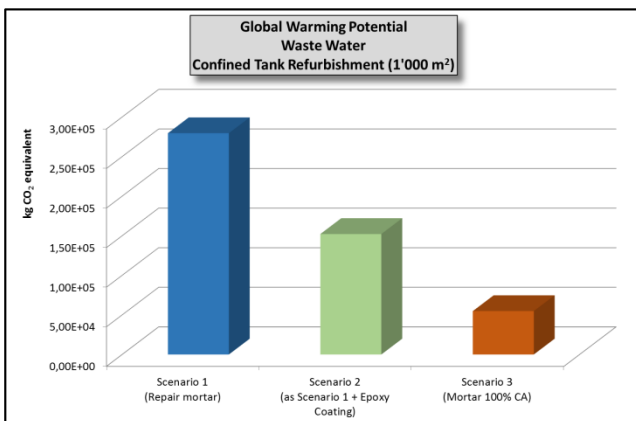
Fig. 2: Global Warming Potential, for a lifespan of 50 years.

Using the 100% Calcium Aluminate technology will minimise the potential contribution to climate change by significantly reducing the emissions of carbon dioxide.

When compared to Scenario-1, the CO₂ saving per year using the 100% calcium aluminate mortar is equivalent to the CO₂ issued during the transport of 24.7 Tonnes (typical full truck capacity) of product by truck for over ~150'000 km, which is equivalent to more than three times the worlds circumference (the figure is still approx. half this amount for Scenario-2 at ~67'000 km).

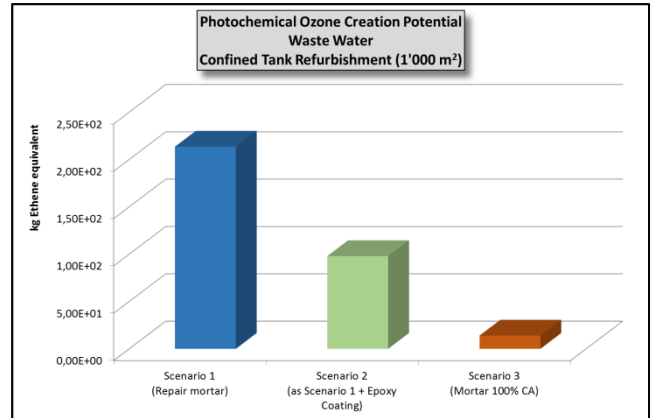
Fig. 3: Photochemical Ozone Creation Potential for a lifespan of 50 years.

Scenario-3 also has the lowest impact in the category of ozone creation potential.

When compared to the Scenario-1, the VOC saving per year using the 100% calcium aluminate mortar is equivalent to saving ~115 tons of solvent based coating (the figure is ~49 tons when compared to Scenario-2).

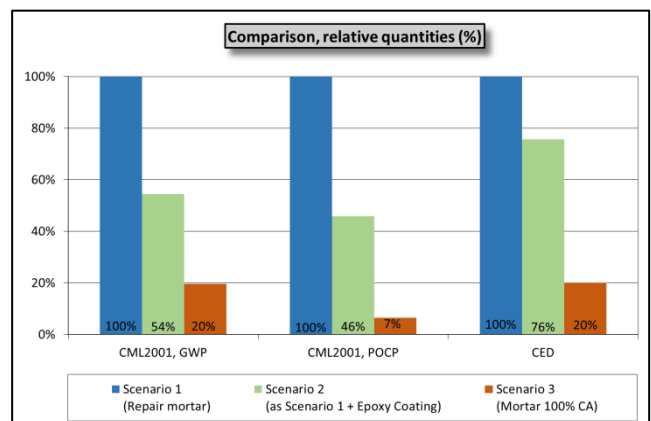
Fig. 4: Comparison of the three categories – Scenario 1 being used as reference.

In addition to providing substantial cost & time savings, the use of this type of mortar significantly decreases the impact to the environment (reductions of 90 to 99% when compared to Scenario-1 - refer to Fig. 4 above; and reductions of 98 to 83% when compared to Scenario-2 – refer to Fig. 5 above).

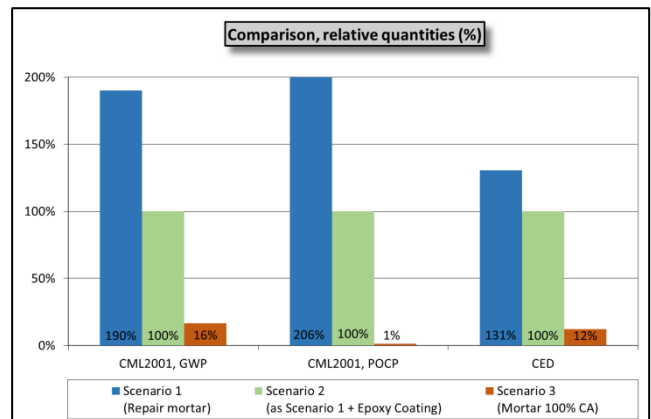
Fig. 5: Comparison of the three categories – Scenario 2 being used as reference.

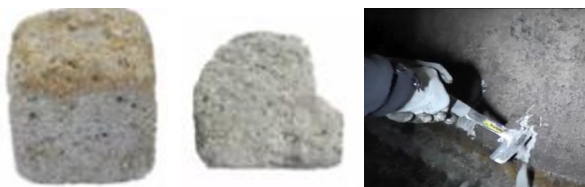
Fig. 6 & 7: OPC mortar containing fly ash, silica fume and silica sand after 1 year in an incubation chamber simulating the biogenic corrosion – the picture on the left being the cube at the start of the test and the one in the middle at 1 year later (3).

Fig. 8: The picture on the right is in a large waste collector near Paris, where a repair mortar is being scratched off easily, due to its deterioration by biogenic corrosion, just a few years after the installation.

Scenario-1 entails higher environmental impact in the three categories compared to the others. This is due to the necessary repetition of the retrofitting, as all types of Ordinary Portland Cement based systems are very sensitive to acid attack generated by biogenic activities.

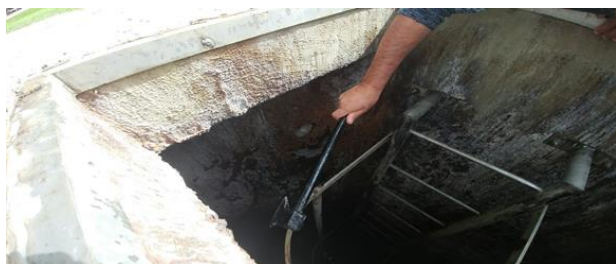
Fig. 9: Picture taken in Israel where a system similar to Scenario-2 has shown premature failure after just 5 years in service.

Scenario-2 also has significant impact in each of the three categories; though lower than Scenario-1. This is because the system comprises epoxy resin based materials that have some environmental impact.

Additionally, the relatively frequent repetition of the retrofitting being required, also increases this impact.

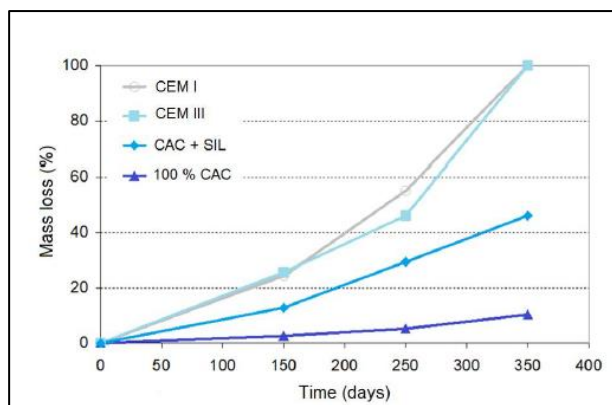
Fig. 10: Weight loss over time from four cementitious materials exposed in the Hamburg Simulation Chamber [6] for one year.

This is due to the long service life and durability of the calcium aluminate based repair mortar in this type of environment. Investigations in incubation chambers [6] and in real-life similar environments have shown that these mortars have a very low degradation rate.
